An Archeological Curation-Needs Assessment for the U.S. Navy, Engineering Field Activities, West and Northwest, Naval Facilities Engineering Command

Archaeological Curation-Needs Assessment
Technical Report No. 9

Amy E. Halpin and Kelly L. Holland

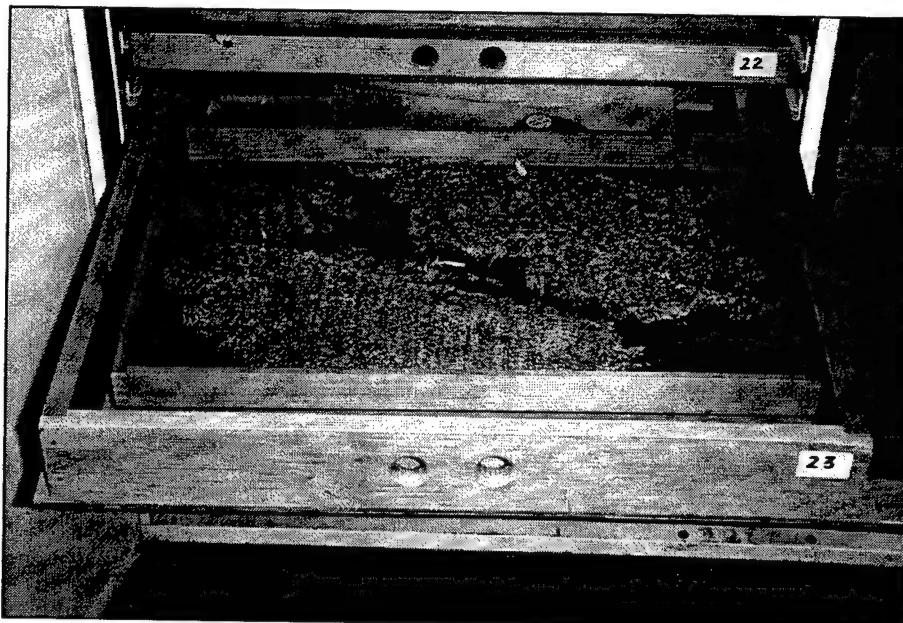
Figure 70. Textiles are labeled with paper tags attached with cotton string.

Artifacts have been cleaned, and have been labeled with india ink directly on the artifact or on a coat of white paint. Most labels are sealed with a clear, protective coating. Materials such as textiles have acidic-paper tags attached to them with cotton string (Figure 70).

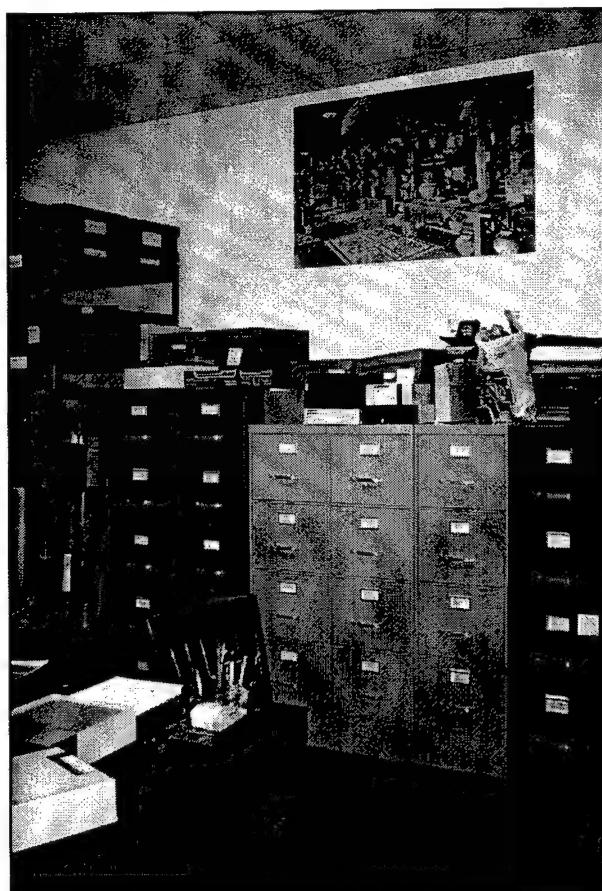
Figure 72. Collections Storage Area 1 at NHMLAC also houses associated records from San Nicolas and San Miguel Islands.

tives are included. Collections from both Woodward and Rozaire are represented. The condition of the collection has deteriorated; some documents are yellowed, torn, or stained. Only a few documents are labeled.

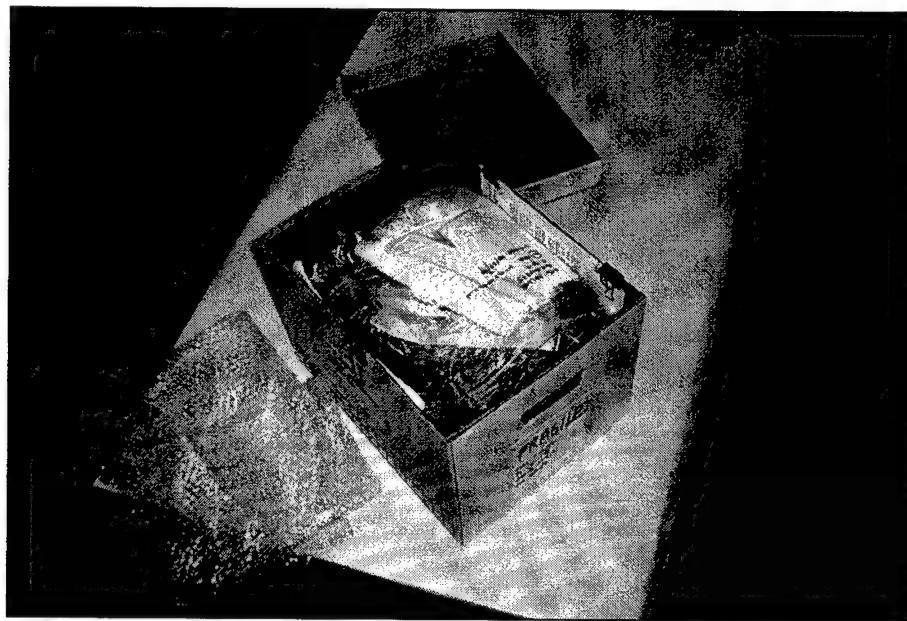
Figure 77. Secondary containers at NSM Repository 2 include plastic bags, bubble wrap, and paper towels.

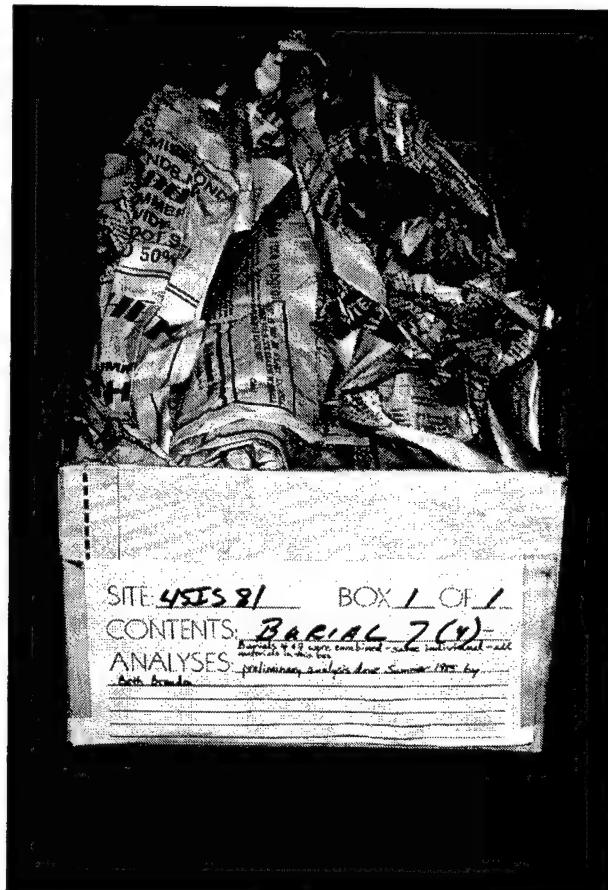
Figure 90. Some archeological materials at SCCC are wrapped in newspaper.

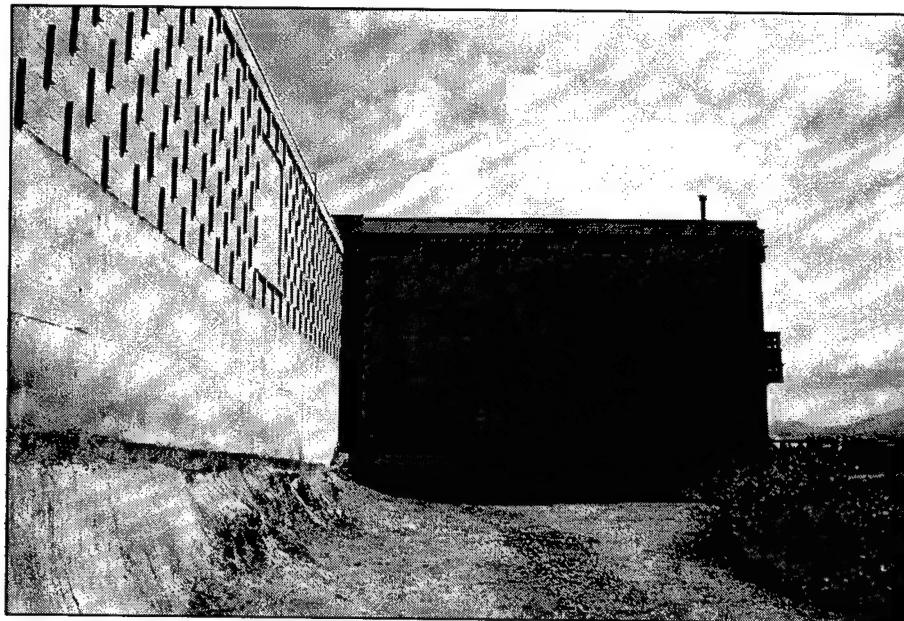
Figure 92. Exterior view of SCHM showing the east wing and loading dock and the original building with irregular foundation.

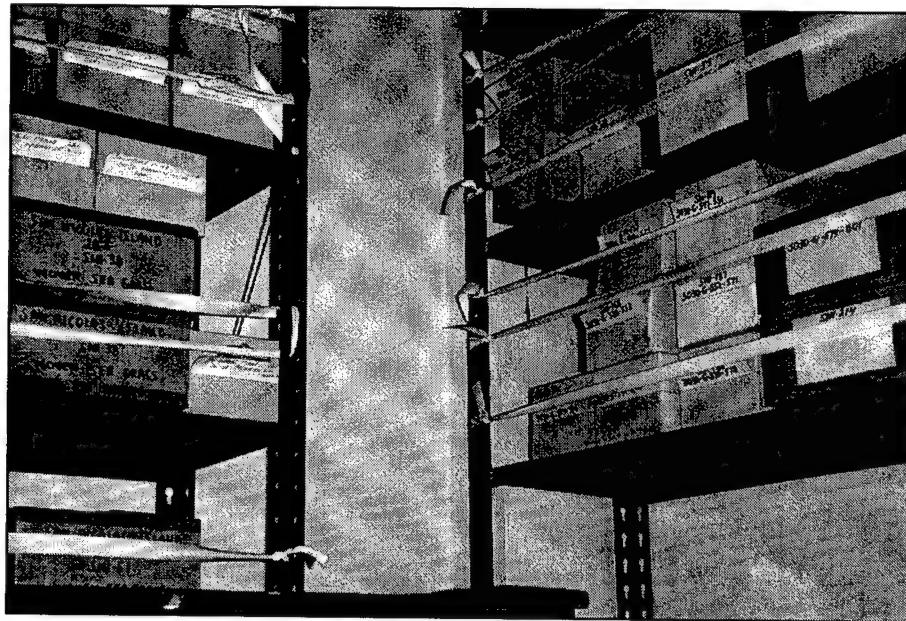
Approximately 25 ft³ of boxed archeological collections are stored on enameled, metal shelving units that are fitted with unsealed plywood shelves. These units measure 3 x 12 x 1 feet (w x h x d), and contain seven shelves per unit (see Figure 96). Boxes are stacked 2–3 high on the shelves. Lengths of basting tape have been stretched across the fronts of the shelves as a precaution against earthquake damage. Storage units have adhesive labels written in marker. Label information consists of rack (shelving unit) and expedition numbers and shelf letters (e.g., #56 San Nicolas Island 28F A–H). The number "56" denotes the rack number, "28F" the expedition number, and "A–H" the shelf letters.

Figure 96. Archeological collections at the Southwest Museum are stored on enamel metal shelving units.

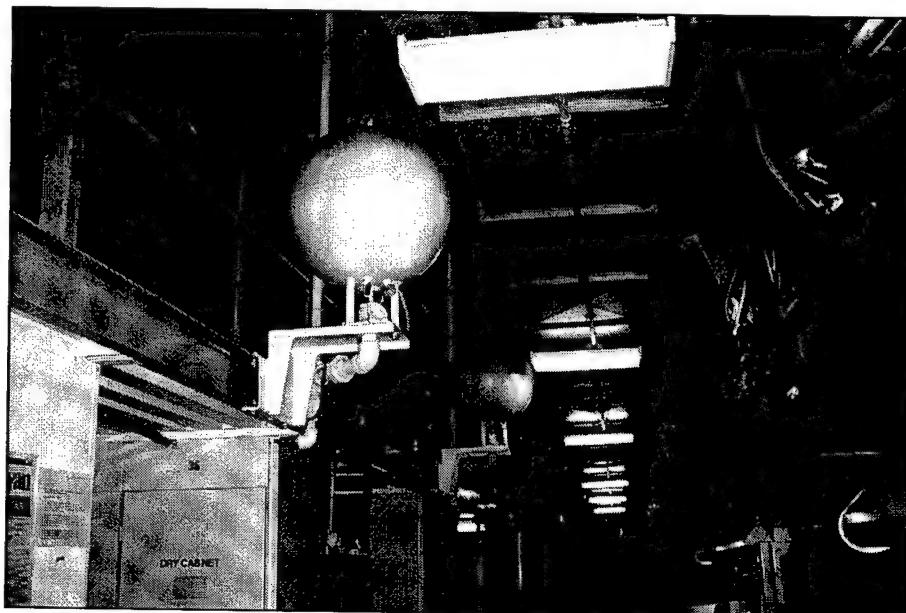
Repository 1 has a halon sprinkler system (Figure 100), smoke detectors, fire walls and doors, heat sensors, portable fire extinguishers, and a fire alarm that is wired directly to the fire department. The fire extinguishers are inspected twice yearly. At the time of the assessment, the extinguishers in the collections storage room had been recently inspected (June 1994).

Figure 100. A halon system is employed in Kroeber Hall for fire suppression.

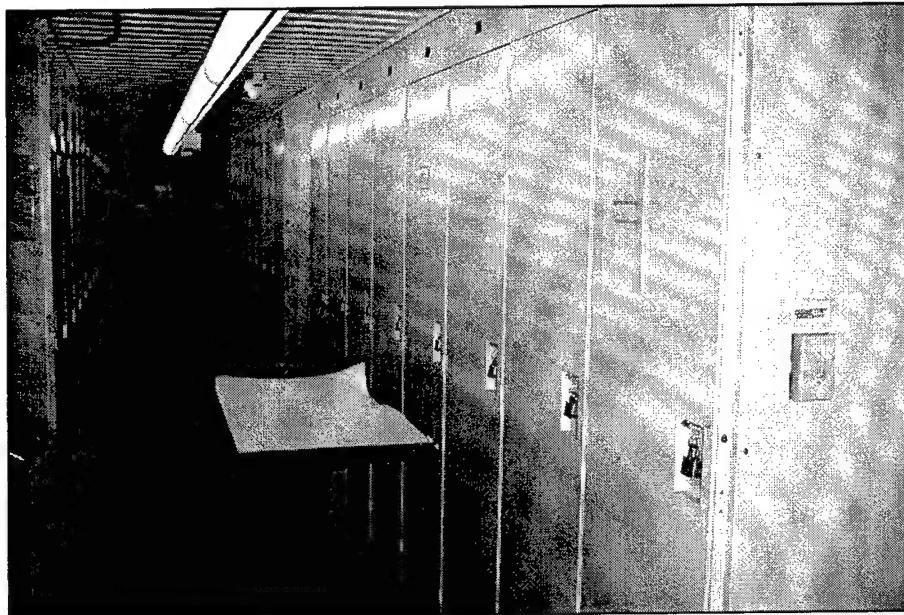
Figure 101. U.S. Navy collections at the Phoebe Hearst Museum Kroeber Hall location are stored in padlocked metal cabinets with Medex and wooden drawers.

building are 70 percent ethnographic and 30 percent archeological. The storage room is at full capacity. Clutter in the area is a result of the quantity of collections stored and the lack of available space.

Storage units present in Repository 1 consist of lockable metal cabinets with Medex and wooden drawers that are painted with gray, fireproof paint (Figure 101); large safes with combination locks; and open steel shelving units on the mezzanine level for oversized objects. The open shelving units have polyethylene curtains draped over them to protect them from both dust and water. Some of the units are directly under pipes that have leaked in the past. Extremely large basketry is suspended from the ceiling in nets. The conservator has them stored in this manner to prevent them from collapsing under their own weight. The St. Louis District team noticed that some large nonfederal objects have been placed directly onto the ductwork for storage. The storage unit that houses approximately 1.6 ft^3 of artifacts recovered from NAS Fallon is a painted metal cabinet bolted to the floor, which is equipped with locked doors.

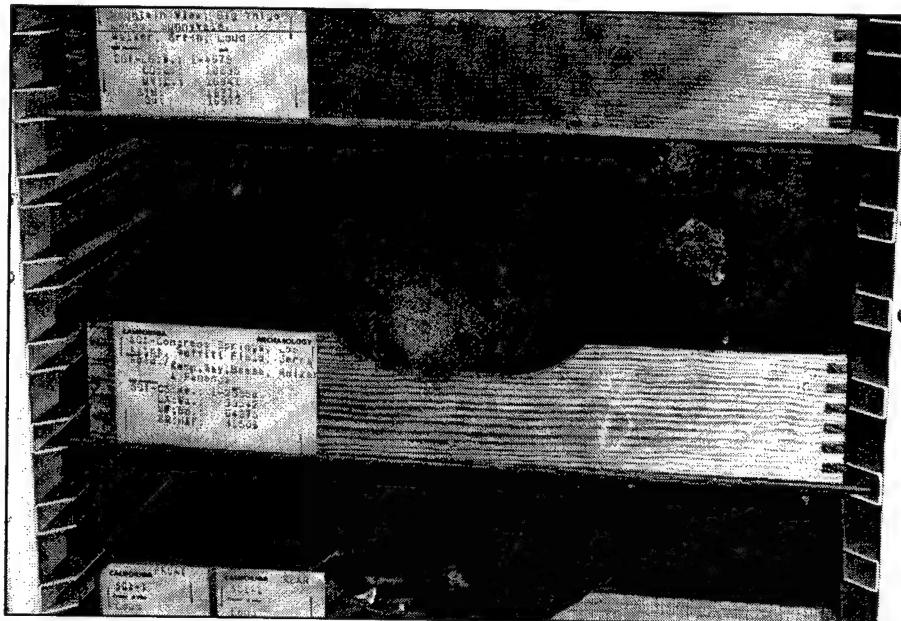
The collections housed in Repository 2 are in drawers (Figure 102). Each drawer is approximately 1.6 ft³. Some of the drawers are unfinished pine or plywood; others are composed of unfinished, formaldehyde-free Medex board. Some drawers have been painted with fireproof, gray paint. The museum is in the process of replacing wooden drawers with Medex drawers. As the collections are being rehoused, all trays are being lined with ethafoam. The labels on each drawer are acidic-paper cards that bear typed site-number information. Additional information has been written in pencil. Most of the drawers are overpacked, which is damaging to the secondary containers within them. The museum is actively working to rehouse the collections, relabeling drawers and updating tray lists.

Figure 102. Storage units at the Hearst Gymnasium for Women consist of Medex and/or wooden drawers in a metal frame.

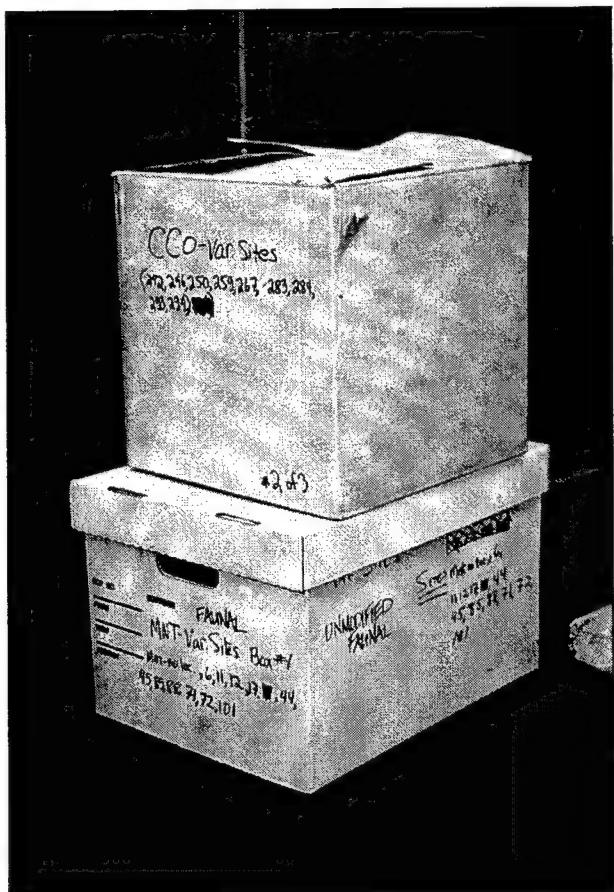
Figure 104. Most of the primary containers housing Naval shore facility collections are acidic-cardboard boxes.

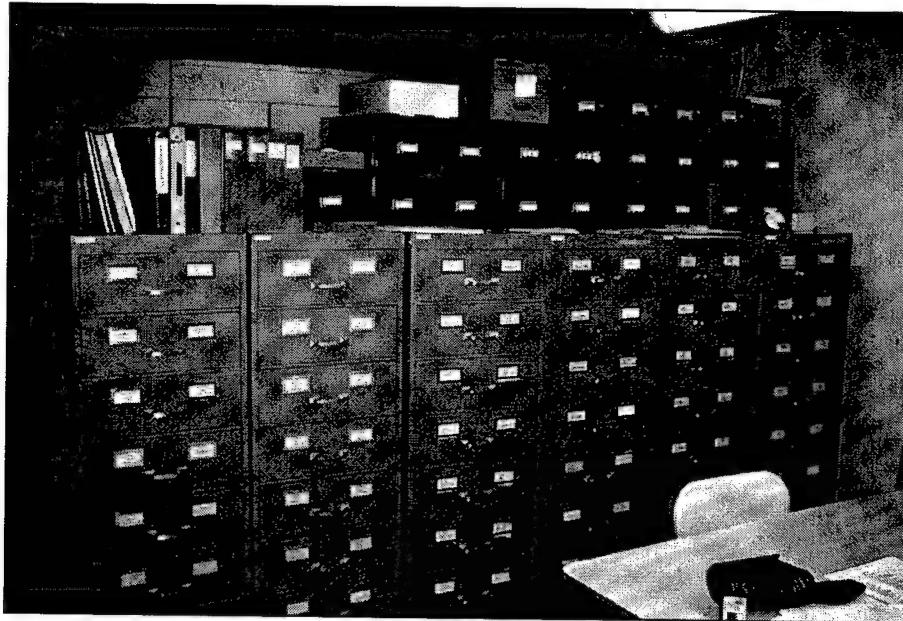
Figure 106. Catalog-card file cabinets in Kroeber Hall at the Phoebe Hearst Museum.

Paper records housed at the Hearst include three copies of accession records. The original accession records are stored on the mezzanine level in Repository 1—Kroeber Hall—in catalog-card file cabinets (Figure 106). A duplicate copy on acid-free paper is stored in the registrar's office in Kroeber Hall. The third (research) copy of the accession records is stored in Room 51, also in Repository 1. All three copies of the accession records are filed sequentially by accession number. A request form must be filled out to gain access to these records. Registrars supervise all work with the documentation.

The archeological archives are filed and stored by manuscript number under the ARF system used at the museum. All contaminants (e.g., paper clips, staples, and rubberbands) have been removed from the original documentation. ARF records are stored in a room off of the main collections storage area in Repository 2. Documents are stored in acidic file folders with acidic, adhesive labels. Research copies are produced upon request. Documentation and most containers are in generally poor condition.

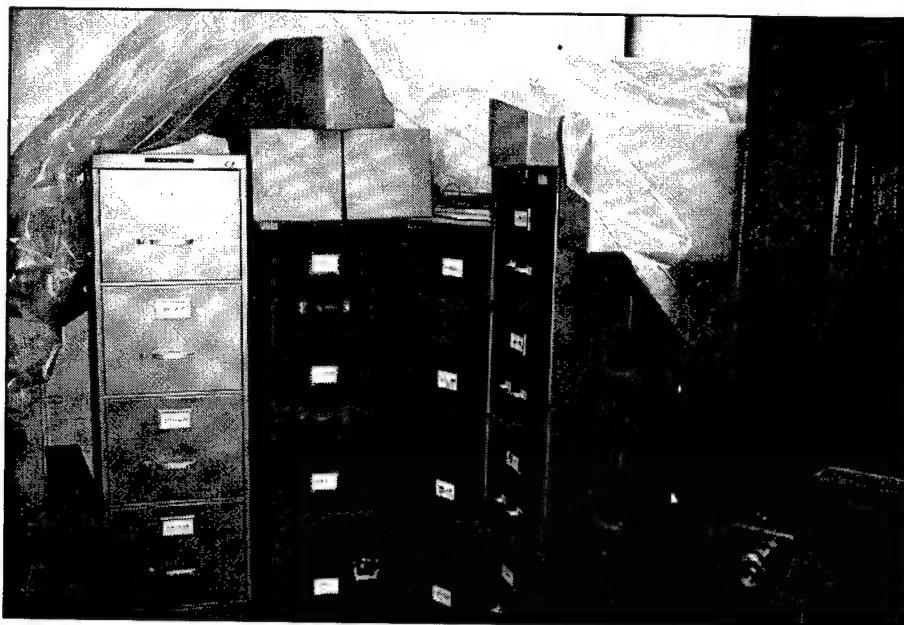
The records-storage room is small, encompassing 88 ft² within Collections Storage Area 1. Less than 1 linear foot of associated documentation is curated in standard, steel file cabinets positioned along the walls (Figure 109). File cabinets are draped with clear plastic sheeting to protect the documentation collections from water seepage.

Paper records are curated in acidic-paper file folders within a standard, letter-size, steel file cabinet. Drawers in the file cabinet are labeled with slips of acidic paper and adhesive tags written in marker. Some records are stored in loose-leaf acidic binders with metal clips. Contaminants such as metal clips, which are showing signs of oxidation, are present. There are no duplicates, and all documentation is on acidic paper.

Figure 109. Less than 1 linear foot of associated records from Naval shore facilities is being curated in metal file cabinets at UCLA.

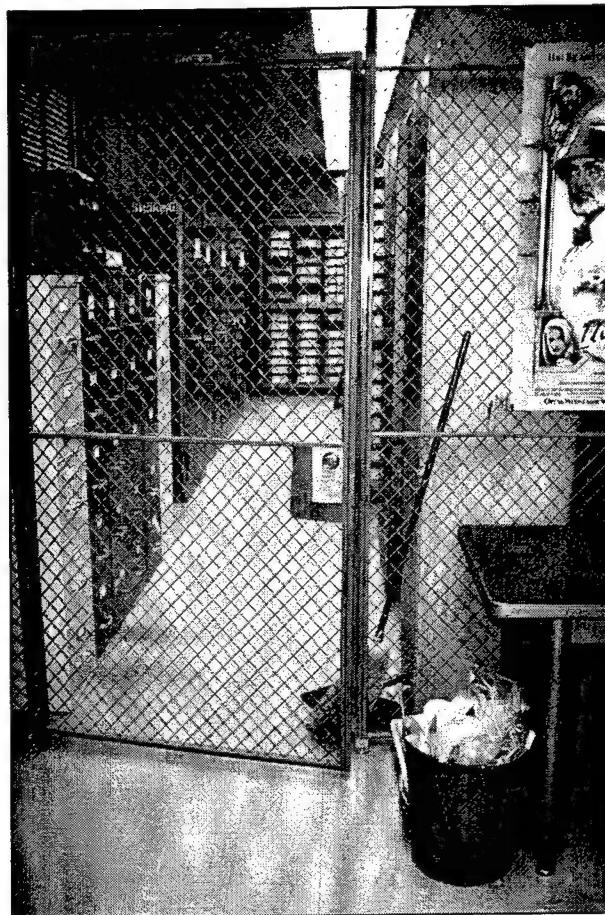
Most of the artifacts and records collections are kept behind a cage-like fence (Figure 111). The majority of the storage units are large, wooden cabinets. Metal filing cabinets, a study table, and some office furniture are also present. The assistant's office is located within this collections area. Collections Storage Area 1 also contains other activity areas, such as an artifact processing lab, an artifact and records study area and a small, connecting office for the assistant curator. The room is filled to 100 percent capacity.

Figure 111. Archeological collections in Collections Area 1 at UCSB are kept behind a secured fence.

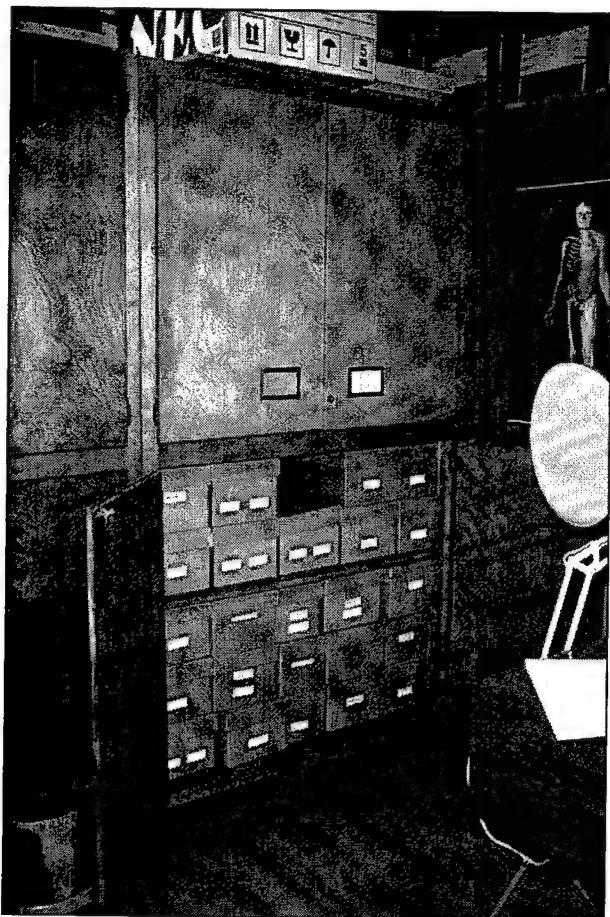
Storage units (Figure 112) within Repository 1, Collections Storage Area 2, are wooden cabinets with locking doors. The cabinets measure 4 x 7 x 2 feet. Each unit has two doors and contains two shelves. Standard-size boxes are stacked in twos and threes within the cabinets. Boxes are also stacked on top of the units.

Primary containers in Repository 1, Collections Storage Area 2, for human skeletal remains are stapled, acidic, cardboard boxes measuring 10 x 7 x 7 inches (see Figure 112). The lids are stapled and telescoping. Labels are typed with accession and burial numbers, and frequently with a short description of the box contents. These adhesive labels are taped to the boxes.

Figure 112. Storage units in Collections Storage Area 2 at UCSB are wooden cabinets with wooden shelves.

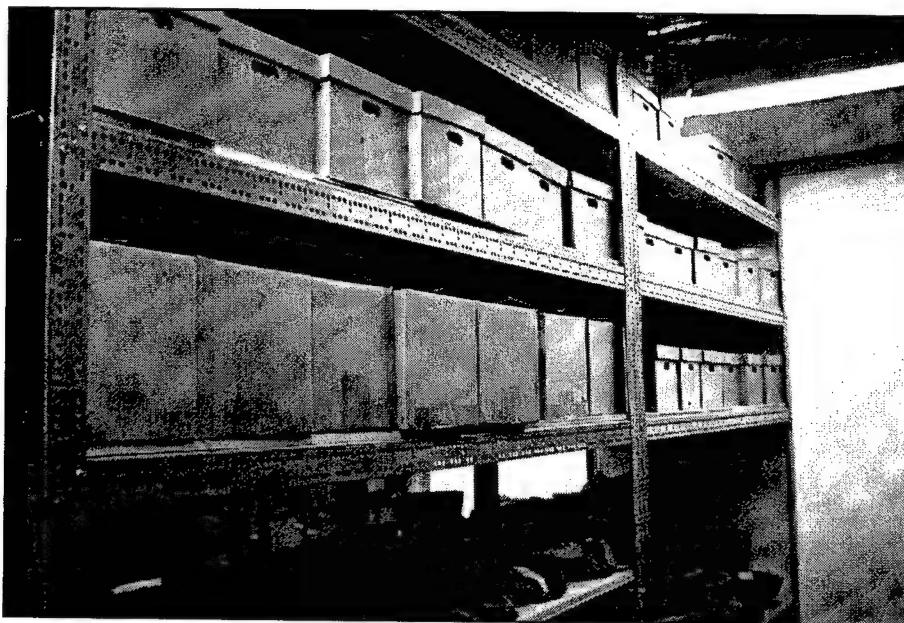
Storage units are large adjustable shelving units composed of metal and wood (Figure 113). Collections in Repository 2 are stored on two different types of metal shelving units. One type contains four shelves and measures 30 x 97 x 48.5 inches. The other type has six shelves and measures 96.5 x 24 x 21 inches. Sixteen of these units constitutes the archeological storage space.

Primary containers are standard, acid-free boxes with telescoping lids (see Figure 113). Containers have a folded construction and are directly labeled in red marker with information including the accession, box, and site numbers.

Figure 113. Storage units in Repository 2 are metal and wood shelving.

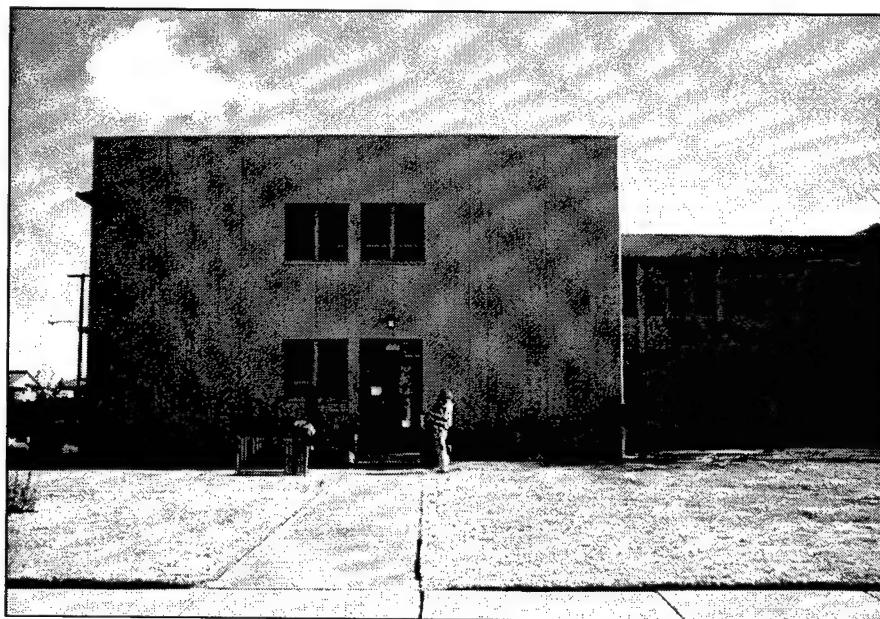
Figure 114. The Stead Building is used for archeological storage, classrooms, and offices.

undergone several re-roofings. No cracks were apparent, but a water stain was noted on the ceiling of the collections storage area. There are two tiled floors, both aboveground; floor tiles in the collections storage area are loosening. The interior walls and ceiling are composed of plaster and wood. No internal or external renovations have been made. The Stead Building is currently used as an office building for the physical plant, classrooms, and a repository.

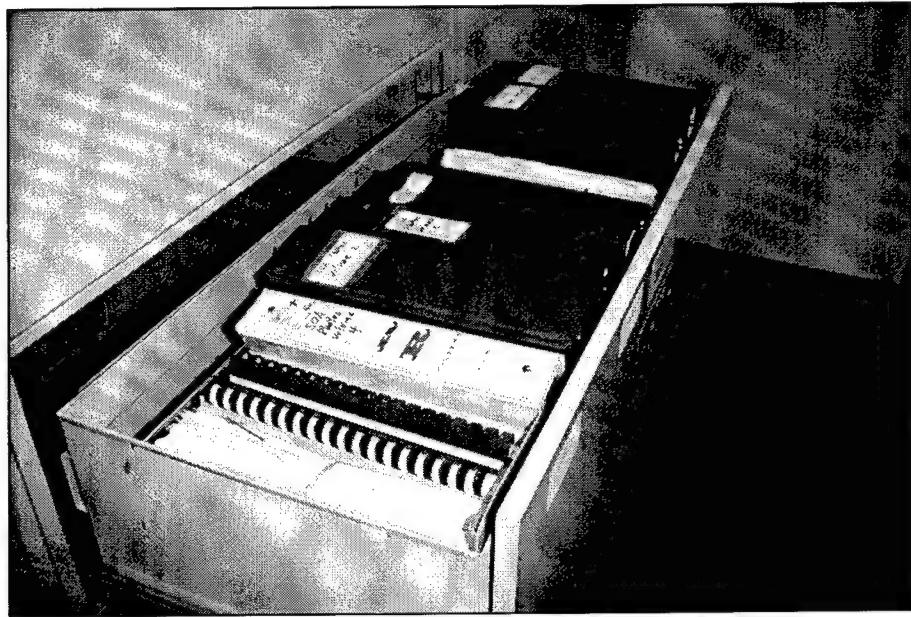
Figure 115. Associated records are stored in lateral file cabinets in Room 505 of the Business Building at UNR.

Records are stored in Repository 1, Room 505. The storage units are lateral filing cabinets measuring 18 x 36 x 65 inches (Figure 115). Drawer labels are written in pen and marker on acidic paper. Each label is either taped to a drawer or inserted into a plastic label holder. The range of the dates is 1986–1989.

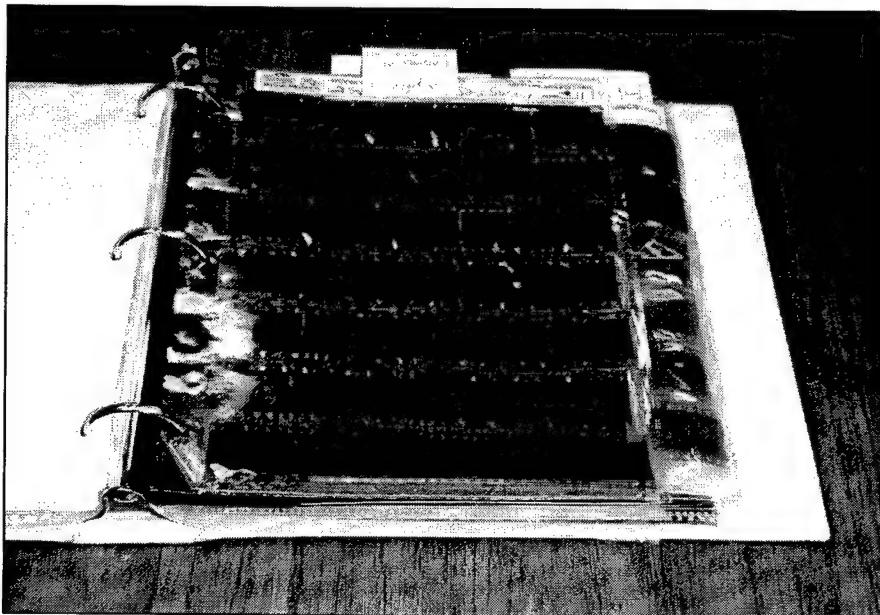
archival plastic sleeves (Figure 116). Black-and-white, 8-x-10-inch photographs are stored in nonarchival three-ring binders. The prints are labeled directly in pencil and in marker on their backs. Photo logs are included.

Figure 116. Photographic negatives are stored in archival-quality negative sleeves in three-ring binders at UNR.

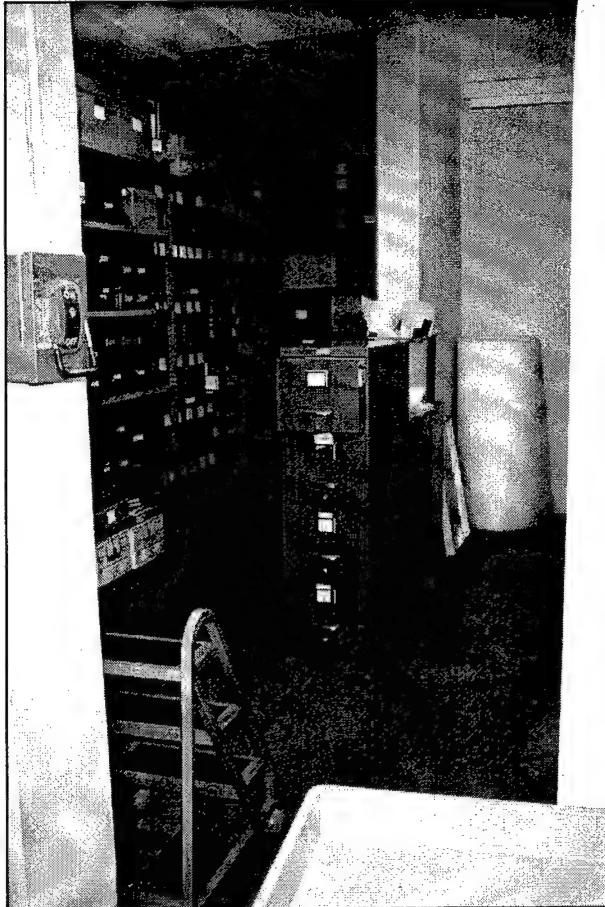
Records are stored in two different locations. Copies of accession records are kept in a metal filing cabinet in Collection Storage Area 2

Figure 121. Accession records are housed in Collections Storage Area 2 of the Burke Museum.

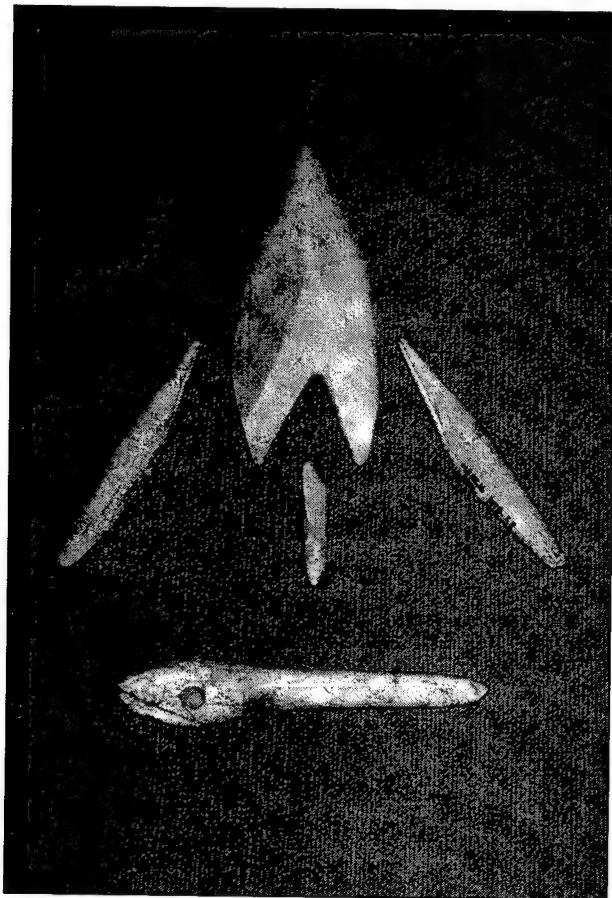
The artifacts (Table 25) have been cleaned and are labeled in india ink on a clear or white background (Figures 126 and 127). Many of the artifacts have tape on them in an attempt to secure them to the material within the display cabinet.

Figure 126. Artifacts including a harpoon, barbs, and a bone point with a carved face are among those located at the Waterhouse, Sr., residence.

1. Return the collection to the Center for Northwest Anthropology, WSU, Pullman. Inventory, accession, rehabilitate, and integrate this collection into the WSU collection.
2. Rehabilitate the artifact storage. Archeological materials should be stored in acid-free boxes.

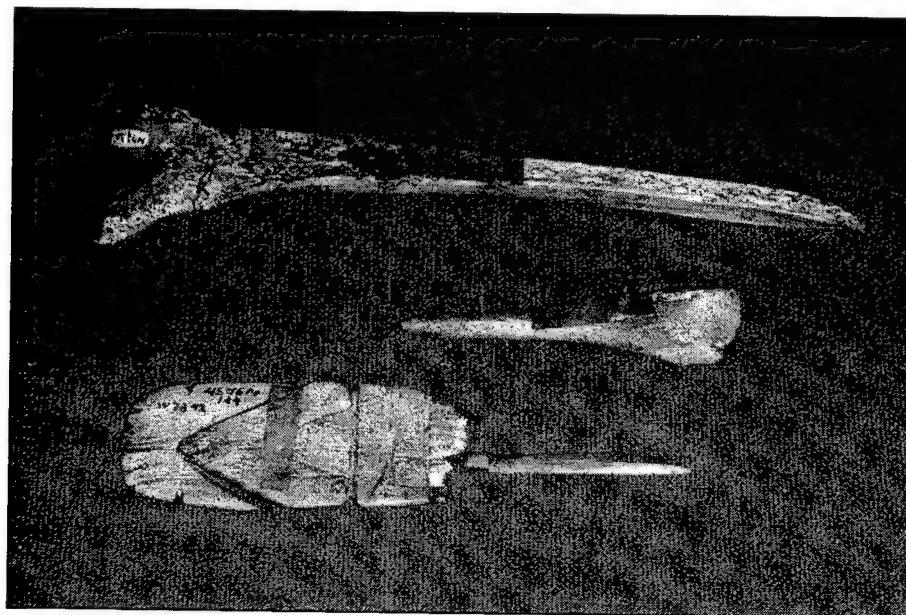
Figure 127. A decorated bone comb and two bone points are among those located at the Waterhouse, Sr., residence.

The secondary containers should be polyethylene, 4-mil, zip-lock bags with labels in indelible ink. Labels on polypaper should be inserted into the closed bags.
